USAAEFA PROJECT NO. 79-07

**ARTIFICIAL AND NATURAL ICING TEST  
OF THE YCH-47D**

**FINAL REPORT**

**JULY 1981**

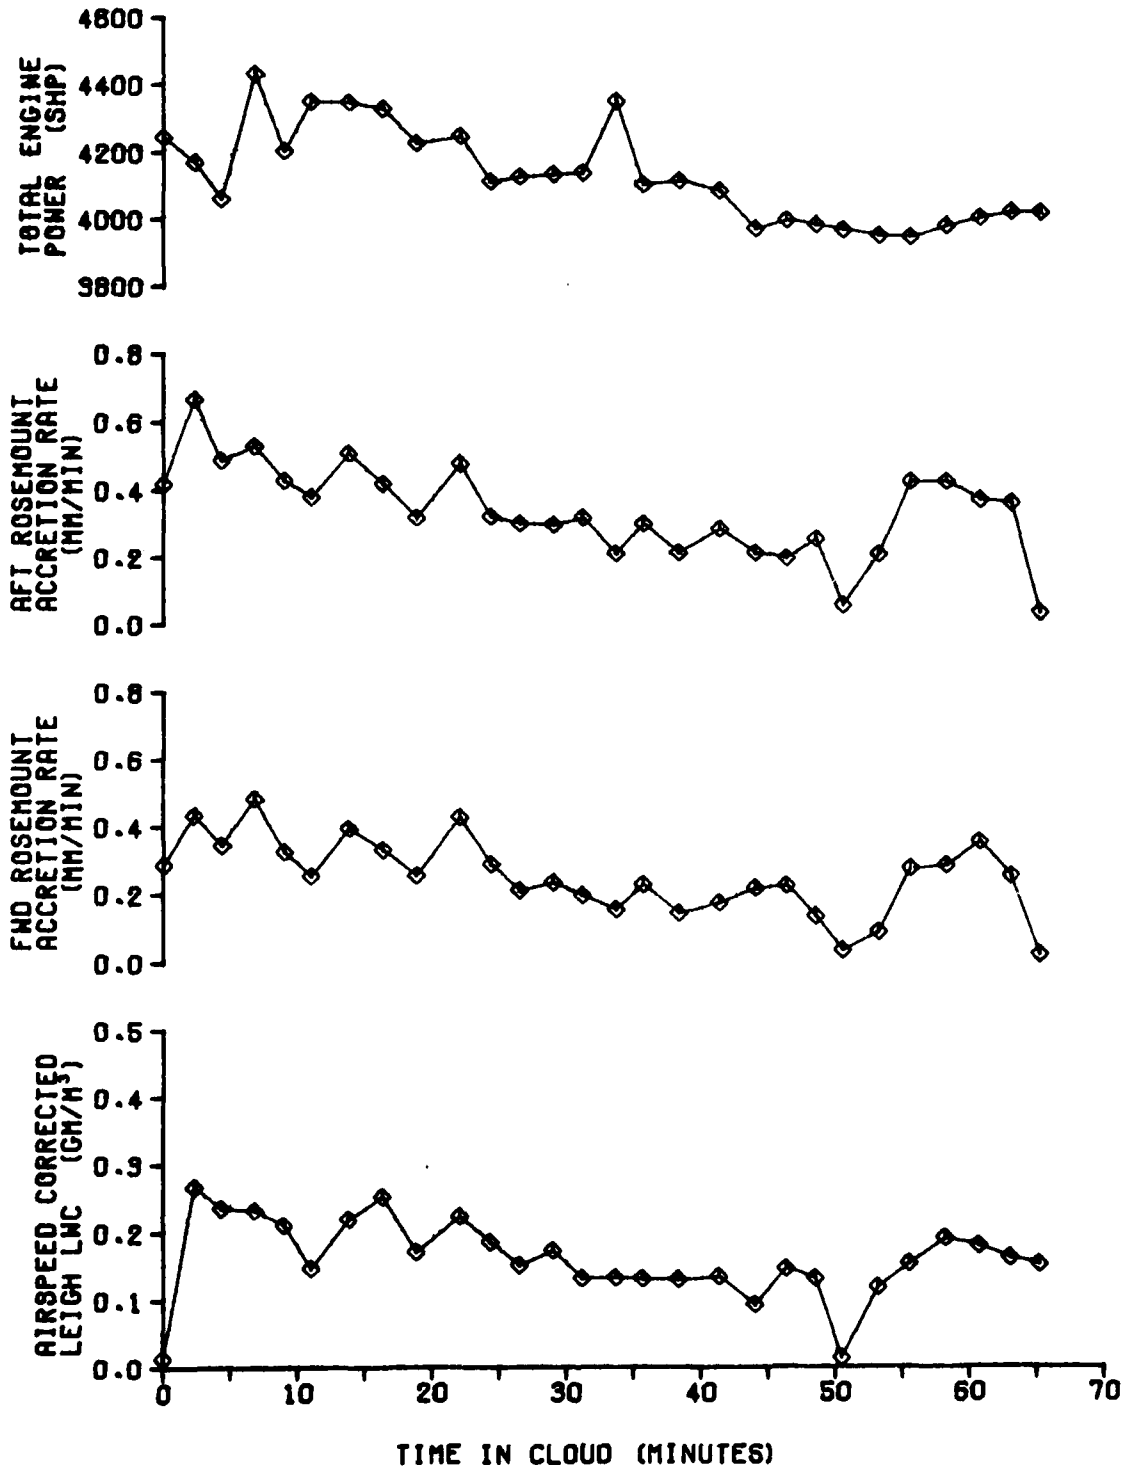
Figure 5

34. Any increase in power required caused by ice accretion was masked by fuel burn off. A typical time history of flight shows the total engine power required during a 66 minute flight in light icing conditions of 0.2 gm/m<sup>3</sup> LWC (figure 5). Power required gradually decreased throughout the flight despite ice buildup. A cloud sweep was conducted upon entering icing condition to determine the altitude which produced the highest LWC. The flight was then continued at that altitude and at a constant airspeed until conditions changed to provide maximum exposure to the icing condition. This flight technique makes a direct comparison of performance

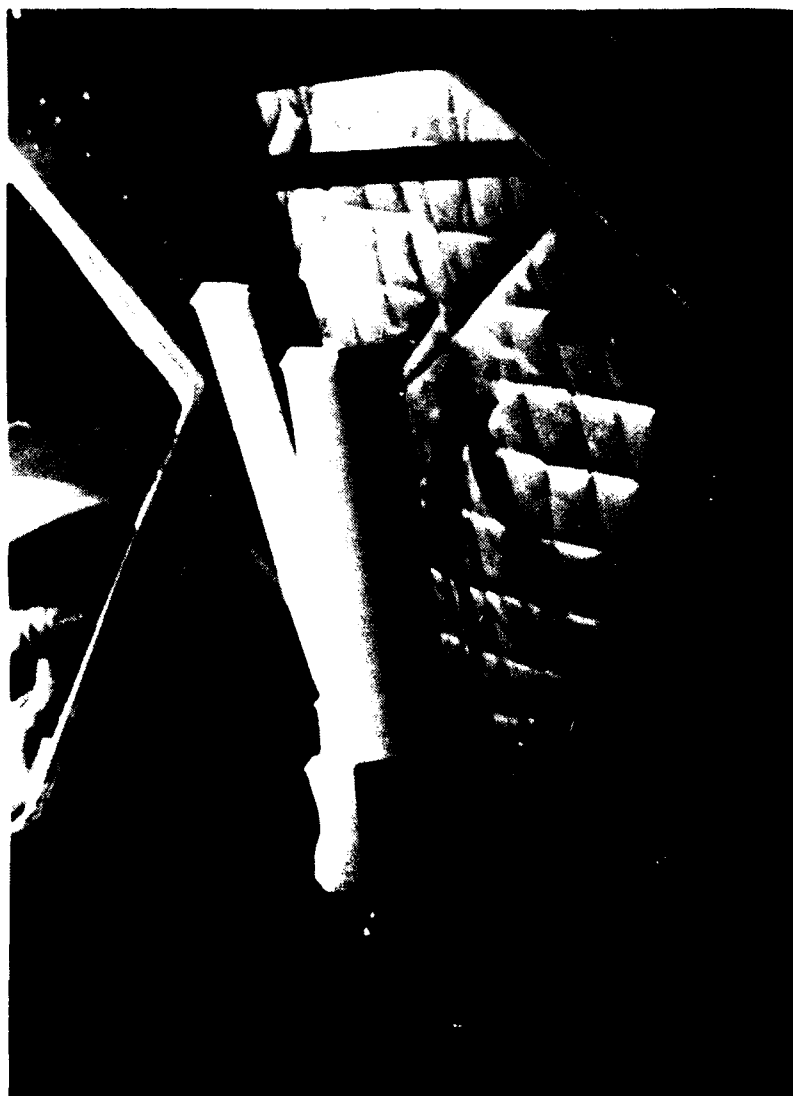
37. The Harvey Smith device was provided by BV and is a "V" shaped device that allowed ice accretion to be read directly from an embossed scale (photo 15, app E).

The ice accretion was read approximately every two minutes by the copilot. The device was deiced by hand prior to starting a new record. The ice accretion rate was recorded and, using a chart for a given airspeed, then converted to a LWC (fig. 2, app D). The ice accretion indicated on this test device exhibited the same trends as those given by the Rosemount and Leigh devices. This test instrument required excessive crew time be devoted to operating and calculating the ice environment and thus is unsuitable for operational use. Night use of this device would also be restricted by inadequate lighting. The Harvey Smith ice detector provides an approximate accretion rate which may be converted to a LWC, however the high crew workload necessary to use the device makes it operationally impractical.

Photo 15. Harvey Smith Vernier Ice Detector

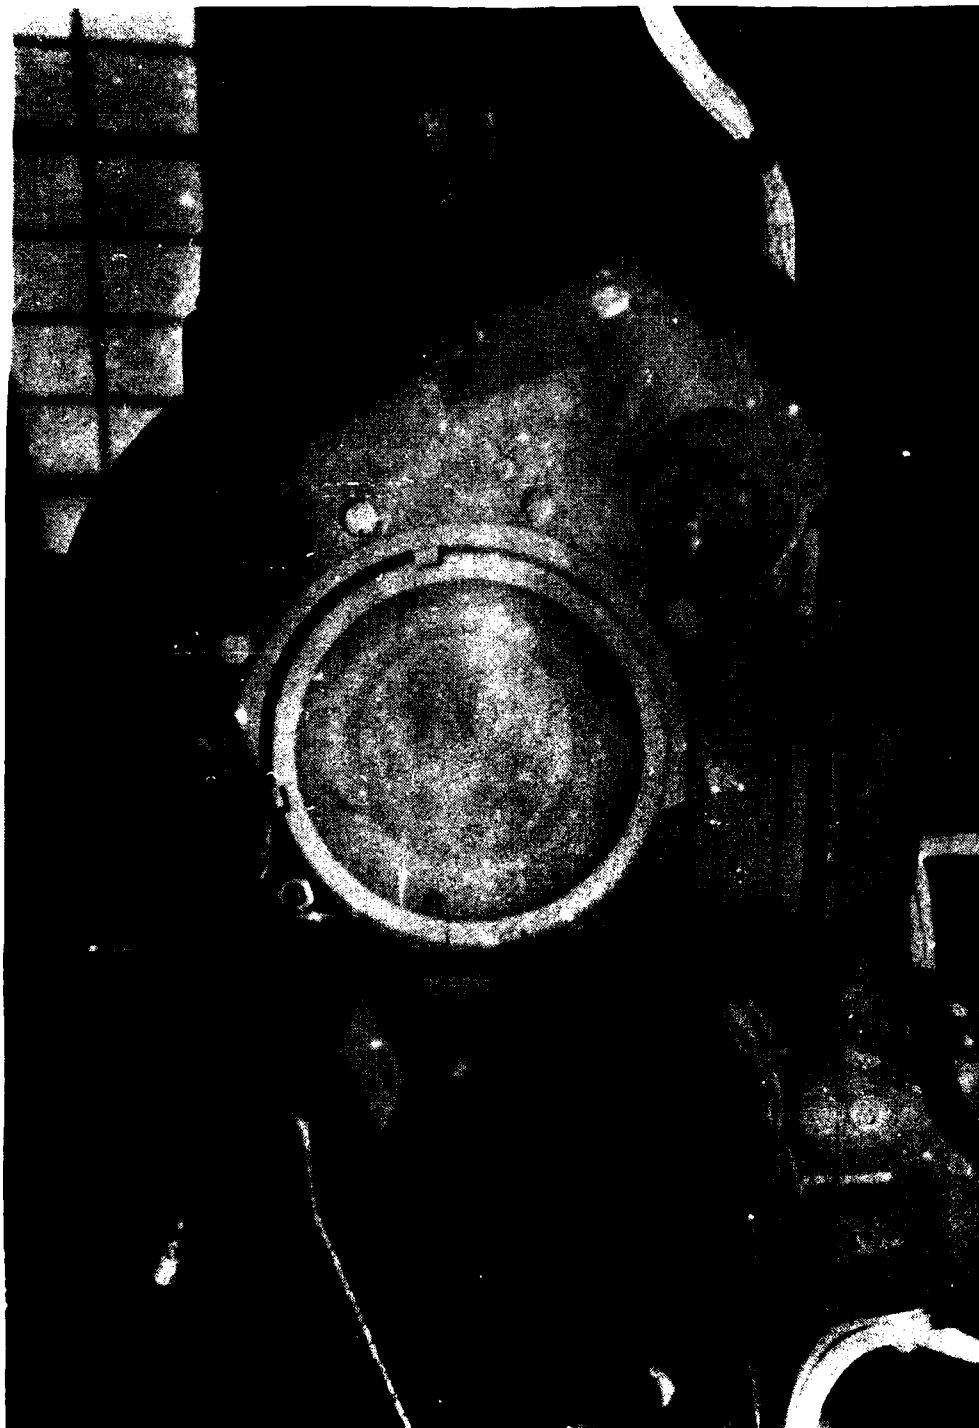
40. The failure of the aft droop stop to engage due to ice accumulation was a deficiency noted during the previous icing tests. A droop stop cover was installed on the aft rotor head to protect the stops, balance arms, and springs as shown in Photograph 17. Ice did not accumulate on the droop stop mechanism after installation of the covers; however, the cover precludes visual observation of the droop stop position during shut down. The droop stop position can be determined by observing the aft rotor tip path plane at low rotor speeds. The aft droop stop covers provided adequate ice protection in the conditions tested.

Photo 17. Aft Rotor Droop Stop Cover
